## CERAMIC ARMOUR

Paul J. Hazell

**Abstract.** This paper reviews the failure mechanisms that occur when a projectile penetrates a ceramic armour. The advantages and disadvantages of using a ceramic-based system are presented and the application of the different ceramics available is discussed.

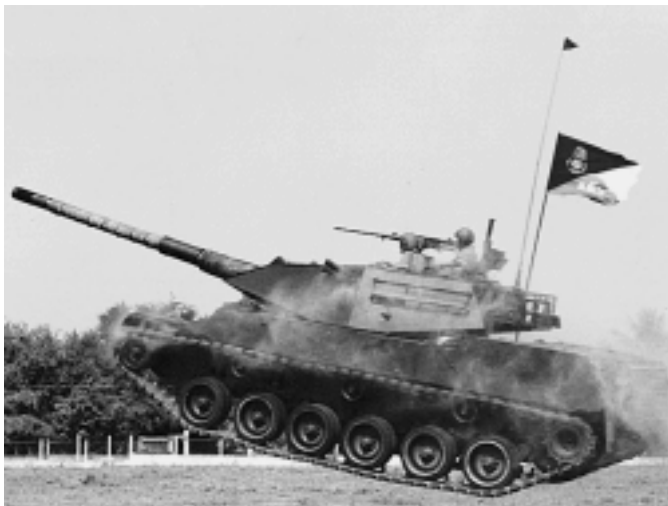
**Figure 1.** A Stingray Light Tank in service with the Royal Thai Army employing ceramic appliqué armour. Reproduced with permission from Jane's Information Group.

have also provided opportunity to provide protection where metals had previously failed. These have included protective vests for the police force, parasitic armour for helicopters, transport aircraft, trucks [4], troop carriers, light tanks (Figure 1), hovercrafts and main battle tanks (MBTs).
